## **Fabrication of Composite Combustion Chamber/Nozzle For Fastrac Engine**

**T. Lawrence, R. Beshears, S. Burlingame, W. Peters, M. Prince, M. Suits, S. Tillery, Marshall Space Flight Center, L. Burns, M. Kovach, K. Roberts, Thiokol Propulsion Group**

### **Abstract**

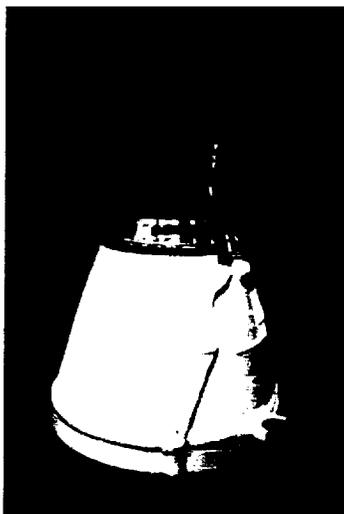
Figure 8: A photograph of a completed nozzle with all the hardware bonded (arrows) and the TPS applied and painted (white region).

Belly Band

Actuator Attachment Ring

Region with TPS

Exhaust Duct Support Bracket

After the overwrap is machined and NDE is performed, additional metal and composite hardware are physically bonded to the nozzle. This additional hardware facilitates attachment of the nozzle to the injector and the Thrust Vector Actuation (TVA) system. This hardware also provides mechanical support for components such as the gas generator/turbopump, igniter, exhaust duct, valve brackets, and drain lines. Figure 8 shows a nozzle with all hardware bonded and the Thermal Protection System (TPS) applied and painted.
